ENFORCEMENT ACTION AGAINST	§	BEFORE THE
LIH WURZBACH MANOR, LP	§	TEXAS DEPARTMENT OF
WITH RESPECT TO	§	HOUSING AND COMMUNITY
WURZBACH MANOR APARTMENTS	§	AFFAIRS
(HTC FILE # 19413 / CMTS # 3277)	§

**AGREED FINAL ORDER**

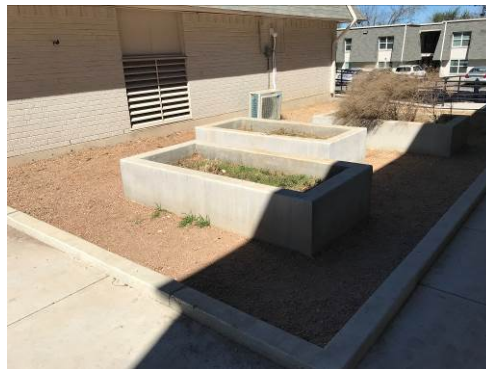
**Item #2 Deficiency:** Accessible Route Within a Site (HUD 11exceptions/TDHCA TAC 10 Rule 1.206/2010 ADA 206.3) This development is subject to ADA design requirements. At least one accessible route connection is not provided from the accessible route to the community garden concrete planters.

- **Corrective Action** – Please provide an architect’s or accessibility specialist’s certification with photographic evidence that the condition has been corrected. The certification must verify that a dedicated no-step pedestrian route located within the boundaries of the site is provided between the accessible route and all common use amenities; all employee work areas, and that the route coincides with or is located in the same area as general circulation paths; is not located in a vehicular driveway in the direction of traffic and has a stable, firm, and slip resistant surface.

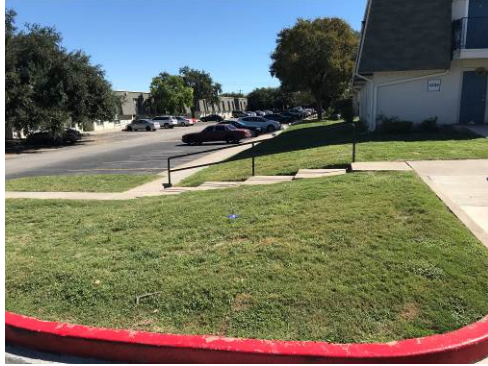
**Item #3 Deficiency: Accessible Building and Facility Entrance (2010 ADA 206.4)** The primary entrance to mobility accessible unit 4246B is subject to ADA design requirements. The route to the entrance has steps with no ramp or lift and is not connected with the accessible route for the property. Additionally, the route that exits on the property to the public street is not an acceptable alternate to the general circulation path.

- **Corrective Action** – Please provide an architect’s or accessibility specialist’s certification with photographic evidence certifying the condition has been corrected at the cited unit and all mobility units. The certification must verify that a dedicated no-step pedestrian route that coincides with or is located in the same area as general circulation paths and is an interior route if the general circulation path is interior connects to the entrances of all common use facilities; employee use work areas; and mobility accessible dwelling units.

Provide a site plan showing the accessible route connecting all accessible parking spaces, mobility accessible units, and public and common use facilities. Indicate on the site plan the locations of all curb-cuts, ramps, handrails, stairs/steps, and overhead hazard cane detection barriers.

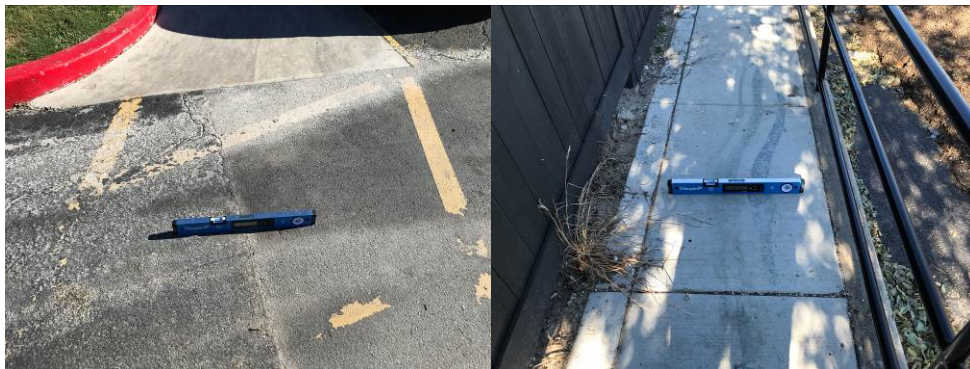
**Item #4 Deficiency: Accessible Route Cross Slope (2010 ADA 403.3)** This development is subject to ADA design requirements. The accessible pedestrian route between mobility accessible unit 4246B and trash enclosure has a cross slope that exceeds the allowed maximum for any slope that runs perpendicular to the direction of travel along the accessible route. The cross slope was more than 2% and as high as 6%.

- **Corrective Action** – Please provide an architect’s or accessibility specialist’s certification with photographic evidence that the condition has been corrected at the location cited and throughout

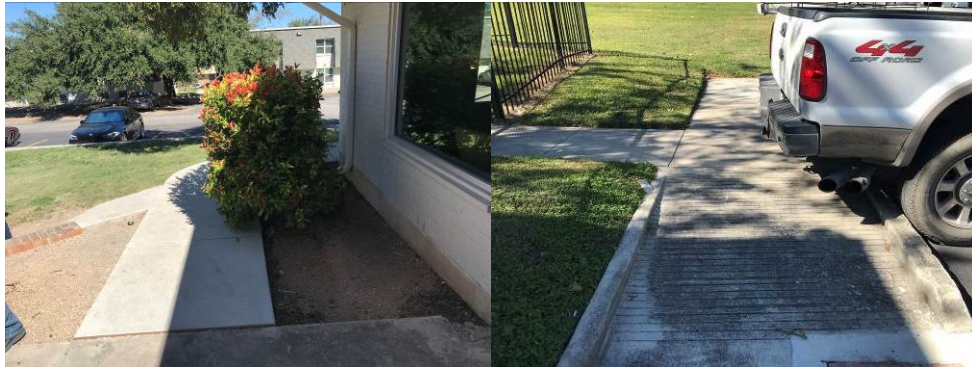
**Item #5 Deficiency: Accessible Route Width (2010 ADA 403.5.1-403.5.3)** This development is subject to ADA design requirements. The pedestrian route near the community center is the only commonly used circulation route to the common use mail kiosk and is required to be an accessible route, however, it does not meet the minimum width requirement for an accessible route. An overhanging bush encroaches on the route width. Additionally, the pedestrian route between the public sidewalk and leasing office is required to be an accessible route, however, it does not meet the minimum width requirement for an accessible route. Overhanging vehicle bumpers encroach on the route width.

- **Corrective Action** – Please provide an architect’s or accessibility specialist’s certification with photographic evidence that the condition has been corrected at the location cited and throughout the accessible route for the property. The certification must verify that the entire route provides a minimum width of 36 inches. Note that route width is permitted to be reduced to 32 inches for short segments of the route no greater than 24 inches long, and where multiple reduced-width segments are separated by segments that are at least 48 inches long and at least 36 inches wide (see illustration)

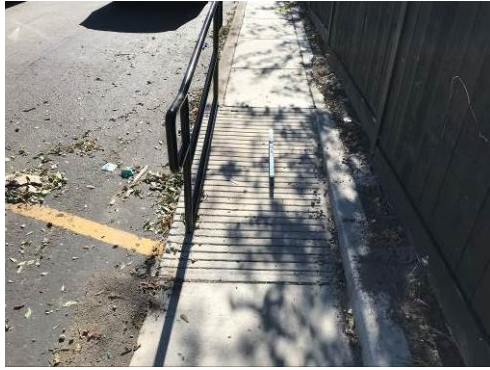
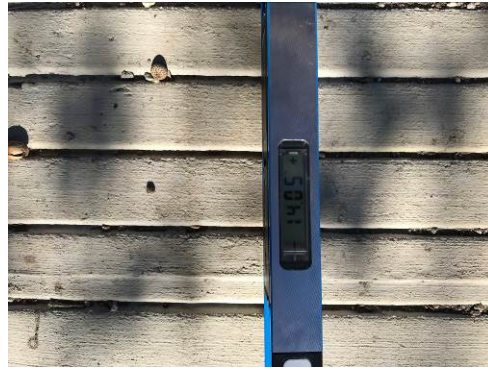
**Item #6 Deficiency: Curb Ramps (2010 ADA 406)** This rehab development is subject to ADA design requirements. The curb ramp located near the trash enclosure is part of the general-use circulation path, however, the slope of the side flares exceeds the maximum allowed.

- **Corrective Action** – Please provide an architect’s or accessibility specialist’s certification with photographic evidence that the condition has been corrected at the location cited and throughout the accessible route for the property. The certification must verify that all curb ramps on general circulation paths meet the following conditions: 1) the degree of slope of any side flares is no greater than 10% (1:10) and a minimum 36 inch wide detour route is provided for cross-traffic around the top of the curb ramp, or the degree of slope of any side flares is no greater than 8.33% (1:12) and a minimum 36 inch wide where a detour route is not provided for cross-traffic around the top of the curb ramp; 2) the counter-slope of the adjoining gutter or road surface immediately adjacent to the curb ramp does not exceed 5 degrees (1:20); 3) a smooth transition with no level change is provided where the bottom of the curb ramp meets the gutter or road surface.

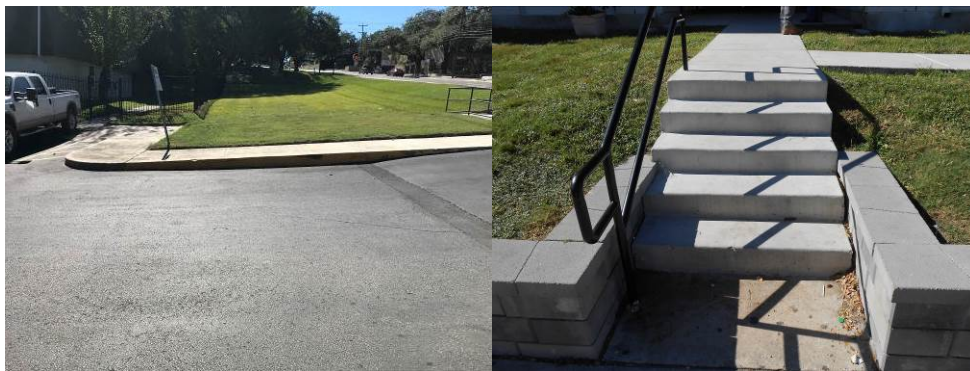
**Item #7 Deficiency: Handrails** (2010 ADA 405.8, 505.2) This development is subject to ADA design requirements. The ramp located near the leasing office is an accessible ramp; however, handrails were not provided on both sides the entire length of the ramp. Additionally the stairs located near building 3 is an accessible stair; however, handrails were not provided on both sides.

- **Corrective Action** – Please provide an architect’s or accessibility specialist’s certification with photographic evidence that the condition has been corrected at the location cited and at all ramps with over 5% slope and with a rise of over six inches and accessible stairs that are part of a means of egress throughout the property. The certification must verify that accessible stairs and ramps meet each of the following handrail specifications: 1) handrails are provided on both sides of the stairs and ramps; 2) rail height is between 34-38 inches, measured vertically from the top of the rail to the stair nosing or ramp and landing surface; 3) the size of handrail gripping surface is from 1¼-2 inches in diameter; 4) clearance around all rails is at least 1½ inches; 5) there are no supports or mounting brackets on the top or sides of handrails; 6) bottom-mounted rail supports are at least 1½ inches long; and 7) handrail extensions are provided meeting all specifications required under ADA 505.10.

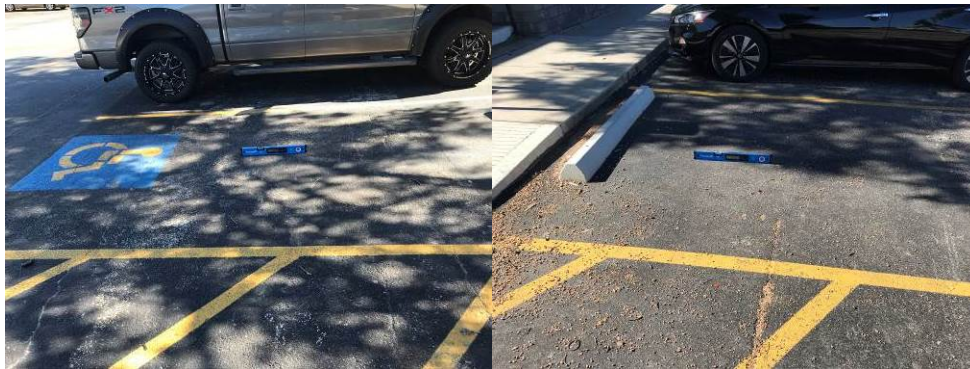
**Item #8 Deficiency: Accessible Car Parking Space (2010 ADA 502.2)** This development is subject to ADA design requirements. The accessible parking spaces reserved for mobility accessible units 4362B & D, 4334B & D, 4311B & D, and the community center do not have a level surface.

- **Corrective Action** – Please provide an owner’s certification with photographic evidence that the condition has been corrected at the location cited and at all accessible parking spaces on the property. The certification must verify that all accessible parking spaces meet the following conditions: 1) spaces are located adjacent to accessible access aisles; 2) marked car spaces are at least 96 inches wide (line center to center); 3) marked van spaces are at least 96 inches wide if the adjacent access aisle is 96 inches wide, or 132 inches wide if the adjacent aisle is 60 inches wide; 4) spaces have a level surface (max. 2% slope for drainage); 5) spaces are not obstructed; and 6) accessible parking spaces have a vertically mounted sign designating the parking space as reserved for accessible parking and containing the words “van accessible” for van spaces.

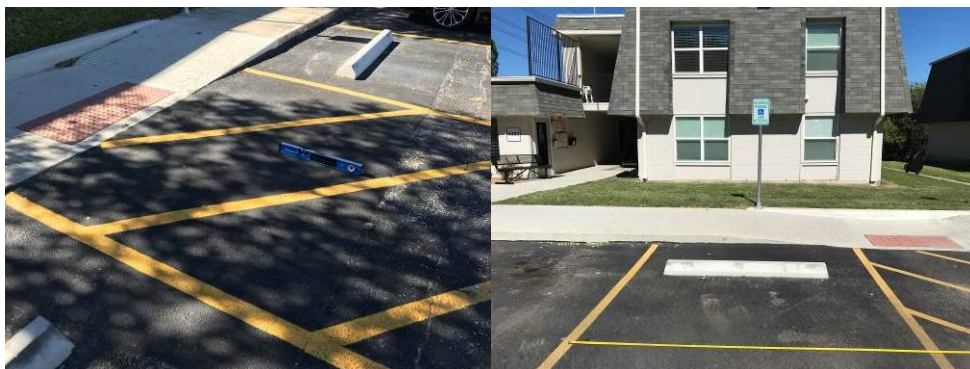
**Item #9 Deficiency: Accessible Parking Access Aisle (2010 ADA 502.3)** This development is subject to ADA design requirements. The accessible parking space reserved for mobility accessible units 4362B & D, 4334B & D, 4311B & D, and the community center do not have an accessible access aisle that is level and unobstructed. Additionally, the accessible van parking spaces reserved for mobility accessible units 4363B & D and the community center do not have an accessible van access aisle of the required minimum dimensions.

- **Corrective Action** – Please provide an owner’s certification with photographic evidence that the condition has been corrected at the location cited and at all accessible parking spaces on the property. The certification must verify that all accessible access aisles meet the following conditions: 1) aisles are located adjacent to each accessible parking space; 2) car aisles are marked to discourage parking within a space that is at least 60 inches wide (line center to center); 3) van aisles are marked to be at least 60 inches wide if the adjacent parking space is 132 inches wide, or 96 inches wide if the parking space 96 inches wide; 4) aisles are marked to discourage parking in them;

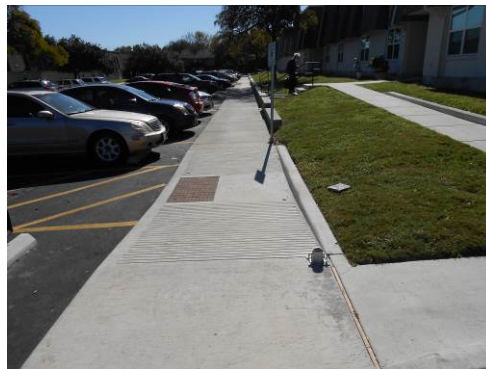
**Item #12 Deficiency:** Accessible Parking Signs (2010 ADA 216.5) This development is subject to ADA design requirements. The accessible parking space located near building 3 did not have an accessible parking space identification sign designating the space as reserved for disabled use only.

- **Corrective Action** – Please provide an architect’s or accessibility specialist’s certification with photographic evidence that the condition has been corrected at the location cited and throughout the accessible route for the property. The certification must specifically verify that all accessible parking signs meet the following conditions: 1) signs include the International Symbol of Accessibility; 2) contain the designation “van accessible” for all van spaces; and 3) are mounted at least 60 inches above the floor or ground surface measured to the bottom of the sign.

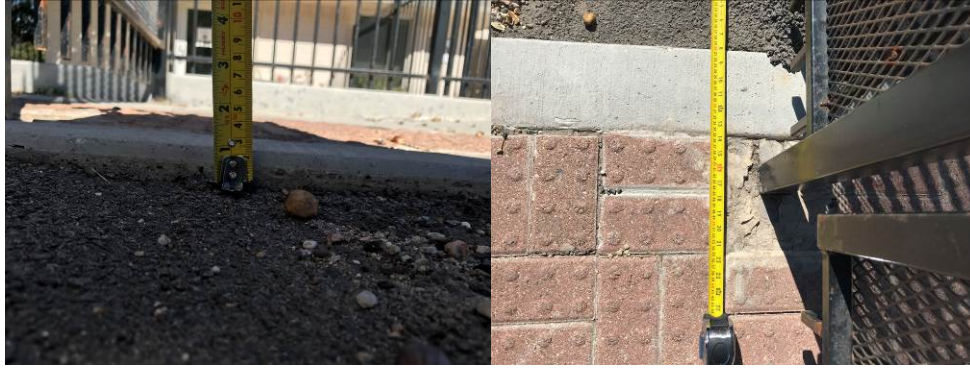
**Item #13 Deficiency:** Door Maneuvering Clearance (2010 ADA 404.2.4) This development is subject to ADA design requirements. The three pedestrian gates do not provide an unobstructed landing or floor space for maneuvering of proper dimensions that is level and clear for a passage door on an accessible route. An accessible route connecting ADA units to all common use facilities, amenities, and site arrival connections (public sidewalk and public transportation stop) is required.

- **Corrective Action** – Provide an owner’s certification with photographic evidence that the door at this location and at all interior and exterior passage doors on accessible routes provide a landing or floor surface area at either side of the door that is unobstructed and level (max. 2% slope – ¼:12) within the perimeter dimensions illustrated below. This includes a clear floor area that extends 18 inches beyond the latch side of a door that must be pulled to open (see upper left diagram).

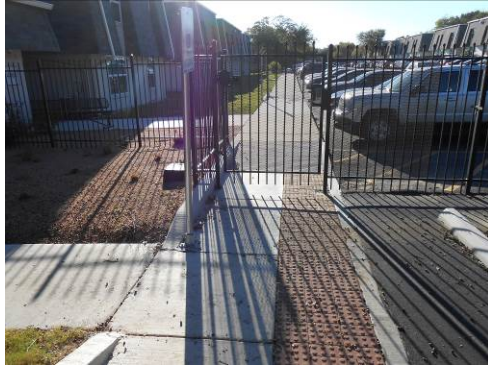
**Item #14 Deficiency:** Door and Gate Surface (2010 ADA 404.2.10) This development is subject to ADA design requirements. The three pedestrian gates do not provide a smooth surface on the “push side”.

- **Corrective Action** – Provide an architect’s or accessibility specialist’s certification with photographic evidence that the gate at this location and at all interior and exterior passage doors and pedestrian gates on accessible routes provide a smooth surface within 10 inches of the finish floor or ground measured vertically on the push side extending the full width of the door or gate. Ensure that parts creating horizontal or vertical joints in these surfaces are within 1/16 inch of the same plane as the other and that cavities created by added kick plates are capped.

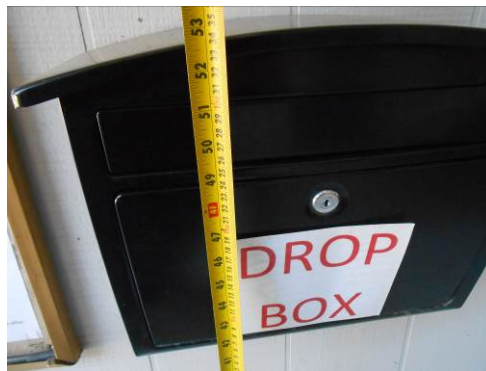
**Item #17 Deficiency: Mailboxes (2010 ADA 205, 308-9)** The leasing office is identified as a common use facility and subject to ADA design requirements. The drop box is more than 48 inches above the ground surface and not within accessible reach ranges.

- **Corrective Action** – Provide an architect’s or accessibility specialist’s certification with photographic evidence that the drop box at this location and at other accessible drop boxes have been corrected or are already correct. The certification should say that they are on an accessible route, and, where the clear floor space is positioned for an unobstructed side (parallel) approach, the height of the drop box is 15-48 inches above the ground surface (an object that is less than or equal to 34 inches high and less than or equal to 10 inches deep is not considered an obstruction).

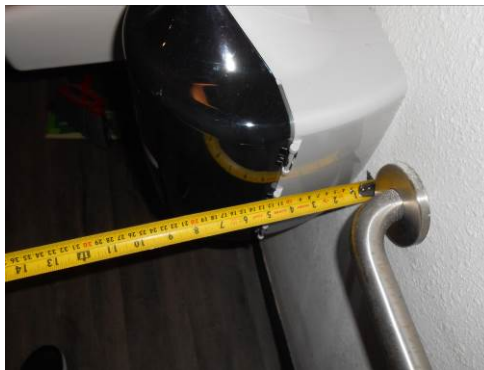
**Item #22 Deficiency: Grab Bars (2010 ADA 604.5)** The leasing office is identified as a common use facility and subject to ADA design requirements. The rear grab bar at the accessible toilet in the unisex restroom did not have the required minimum clearance between the bar and the wipe dispenser.

- **Corrective Action** – Please provide an architect’s or accessibility specialist’s certification with photographic evidence that the condition has been corrected at the location cited and at all accessible restrooms. The certification must verify that the grab bars at the back and sidewall of accessible toilets provide the following features: 1) grab bars are mounted horizontally, securely and will not rotate in their fittings; 2) bars are 1¼ inches to 1½ inches in diameter; 3) the center of the bars are 33 inches to 36 inches above the floor; 4) bars have at least 1½ inches of spacing all around and are not obstructed by any dispenser, any other inaccessible grab bar, fixture or architectural element; 5) the sidewall bar is at least 42 inches long with one end positioned no more than 12 inches, and with the other end no less than 54 inches from the corner; 6) bar at the back is at least 36 inches long and positioned so that the end nearest to the sidewall is no less than 12 inches from the centerline of the toilet, and the other end is no less than 24 inches from the toilet centerline.

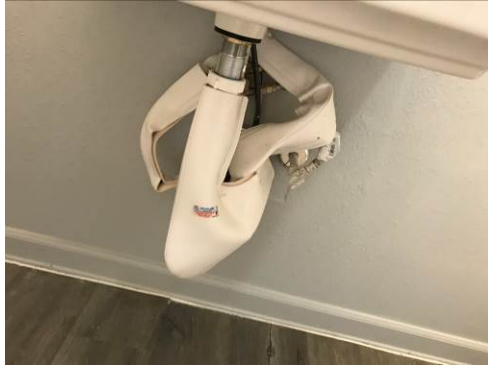
**Item #24 Deficiency:** Exposed Pipes (2010 ADA 606.5) The leasing office and community center are identified as common use facilities and subject to ADA design requirements. The unisex (leasing office) men’s (community center), and women’s (community center) restrooms do not provide adequate protection from exposed pipes and sharp or abrasive surfaces under the lavatory that may cause injury to certain users. The drain line is exposed where the flange meets the lavatory bowl.

- **Corrective Action** – Please provide an architect’s or accessibility specialist’s certification with photographic evidence that the condition has been corrected at the location cited and throughout the accessible route for the property. The certification must verify the following: 1) water supply and drain pipes under lavatories are insulated or otherwise configured to protect against contact; 2) there are no exposed sharp or abrasive surfaces under the lavatory; and 3) the minimum clearance beneath the lavatory is: (a) knee space is 8 inches deep (measured horizontally from the front edge of the counter or lav) at a point that is 27 inches above the floor; (b) leg clearance is 11 inches deep at a point 9 inches high; and (c) toe clearance is at least 17 inches deep a point at least 9 inches high.

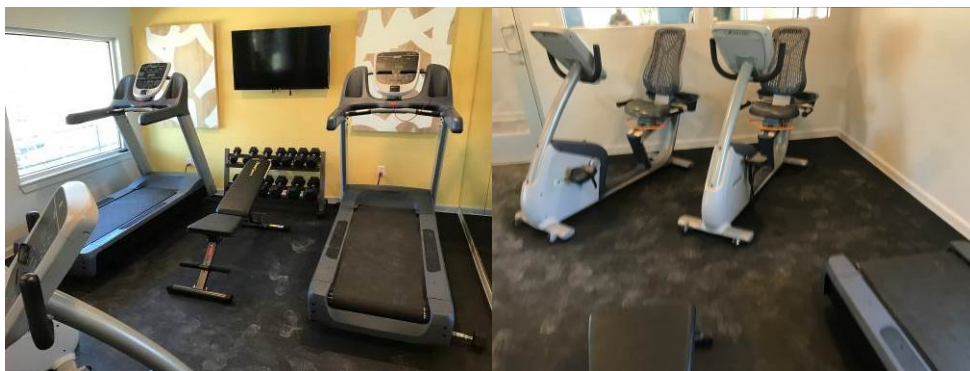
**Item #28 Deficiency:** Exercise Machines Access (2010 ADA 236, 1004.1) The community center is identified as a common use facility and subject to ADA design requirements. The workout facility in the community center does not provide a clear floor space for access to at least one of each type of exercise machine that is located on an accessible route.

- **Corrective Action** – Please provide an owner’s certification with photographic evidence that the condition has been corrected. The certification must verify that a 30 inch x 48 inch clear floor space is provided for transfer or for use by an individual seated in a wheelchair requiring either a parallel or forward approach to at least one of each type of exercise machine.

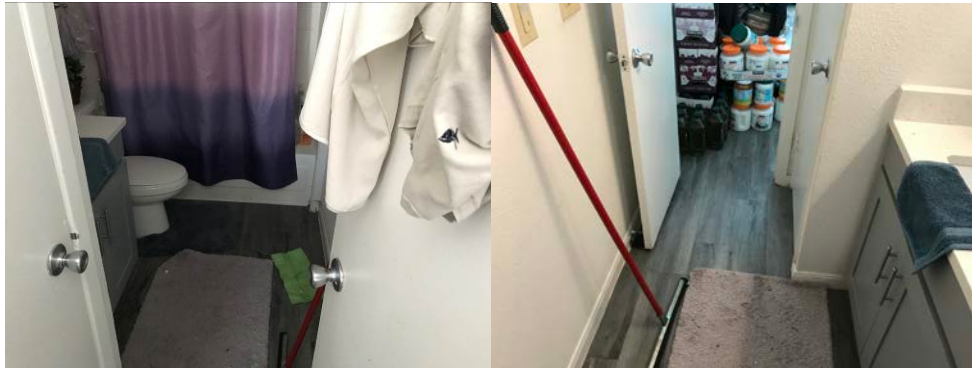
**Item #33 Deficiency: Turning Space (2010 ADA 304.3, 809.2.2)** Units 4311B and 4246B are designated as mobility accessible dwelling unit and subject to ADA design requirements. In dwelling units, a turning space is required in all rooms on an accessible route, including the non-complying bathroom. The turning space required for a user to make an 180° turn in the master bathroom does not provide a 60 inch diameter circle or a T-shaped turning space. Additional mobility accessible dwelling units were not inspected but may also be affected.

- **Corrective Action** – Please provide an architect’s or accessibility specialist’s certification with photographic evidence that the condition has been corrected in the cited unit and all other mobility accessible dwelling units. The certification must verify that a turning space is provided in the master bathroom that meets the following conditions: 1) allows the user to make a 180° turn with a minimum 60 inch diameter circle, or a T-shaped space with unobstructed 36 inch wide and 12 inch deep arms, and minimum 36 inch wide and 24 inch deep base of T; 2) has a surface that is firm, stable and slip resistant, with no abrupt level changes; 3) has a surface slope no greater than 2% (1:48); and 4) adjoins or overlaps an accessible route.

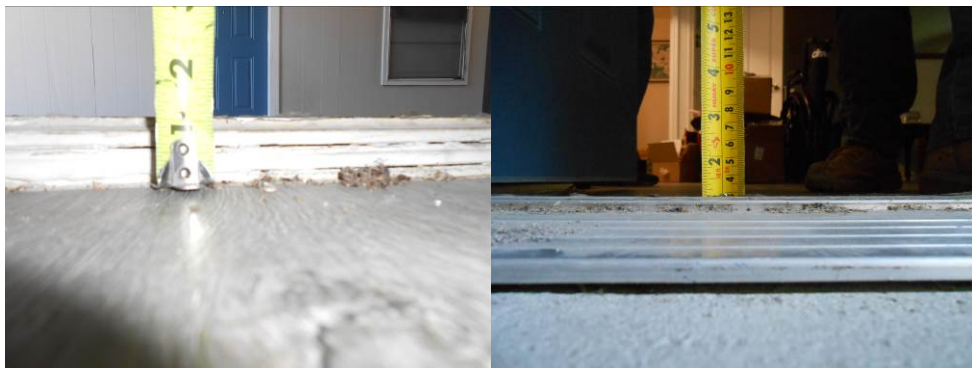
**Item #34 Deficiency:** Threshold Height and Beveled Edge (2010 ADA 404.2.5) Unit 4363B is designated as a mobility accessible dwelling unit and subject to ADA design requirements. The height of the front door threshold is 1 inch. Additional mobility accessible dwelling units were not inspected but may also be affected.

- **Corrective Action** – Provide an architect’s or accessibility specialist’s certification with photographic evidence that the condition has been corrected in the cited unit and all other mobility accessible dwelling units (one sample photo only). The certification must verify that, for all passage doors along the accessible route, the combined height of any threshold plus any change in floor level occurring at the threshold does not exceed  $\frac{3}{4}$  inch for rehabilitation developments (measured from top of threshold to interior floor and exterior landing surfaces). The certification must also verify that threshold heights and other changes in level along an accessible route that are between  $\frac{1}{4}$  inches and  $\frac{1}{2}$  inches have a beveled edge with maximum 1:2 slope.

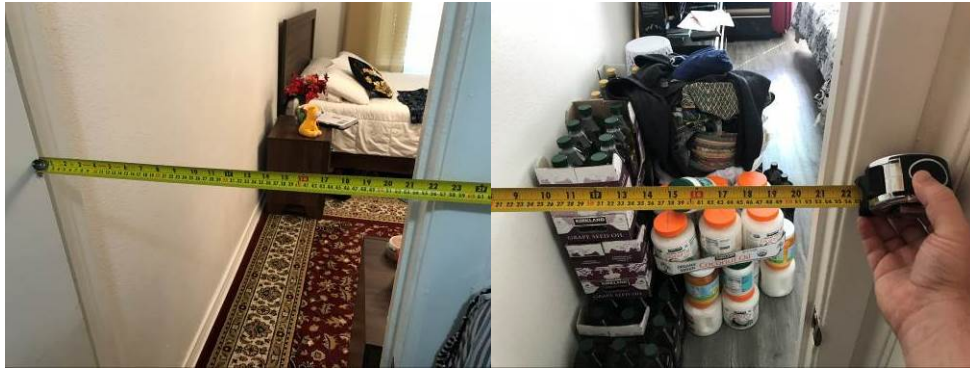
**Item #35 Deficiency: Door Clear Opening (2010 ADA 404.2.3)** In this rehabilitation development, units 4311B and 4246B are designated as a mobility accessible dwelling unit and subject to ADA design requirements. The master bathroom door does not provide the minimum clear opening for a passage door on an accessible route. The clear opening with the door open 90° was 21½ inches. Additional mobility accessible dwelling units were not inspected but may also be affected.

- **Corrective Action** – Provide an architect’s or accessibility specialist’s certification with photographic evidence (one sample photo only) that the door in the cited unit and that all passage doors in all other mobility accessible dwelling units provide at least a 32 inch clear opening width measured from the face of the door when door is opened to 90° to the door stop on the opposite jamb.

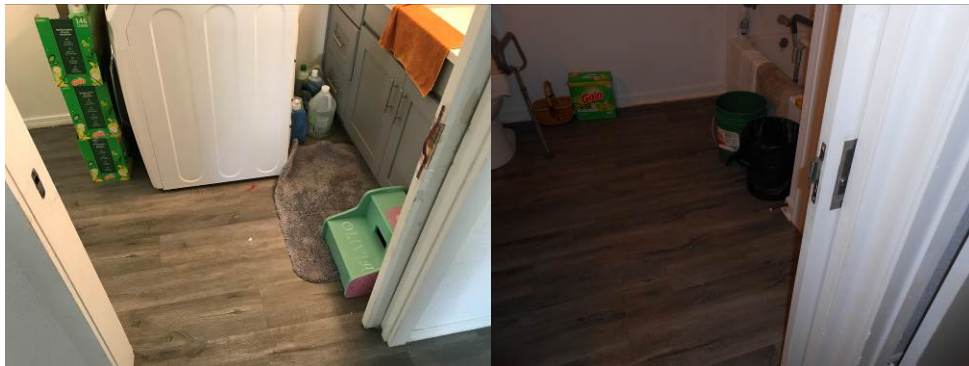
**Item #37 Deficiency:** Operable Parts (2010 ADA 205, 308-9) Units 4363B, 4334B, 4311B, and 4246B are identified as mobility accessible dwelling units and subject to ADA design requirements. The bathroom pocket door hardware requires tight grasping, pinching, or twisting of the wrist. Additional mobility accessible dwelling units were not inspected but may also be affected.

- **Corrective Action** – Provide an architect’s or accessibility specialist’s certification with photographic evidence that the bathroom pocket door hardware at the cited unit and all other mobility accessible dwelling units have been corrected or are already correct. The certification must verify that accessible pocket door hardware does not require tight grasping, pinching, twisting of the wrist, and is on an accessible route, and, where the clear floor space is positioned for an unobstructed side (parallel) approach, the height of the pocket door hardware is 15-48 inches above the floor (an object that is less than or equal to 34 inches high and less than or equal to 10 inches deep is not considered an obstruction).

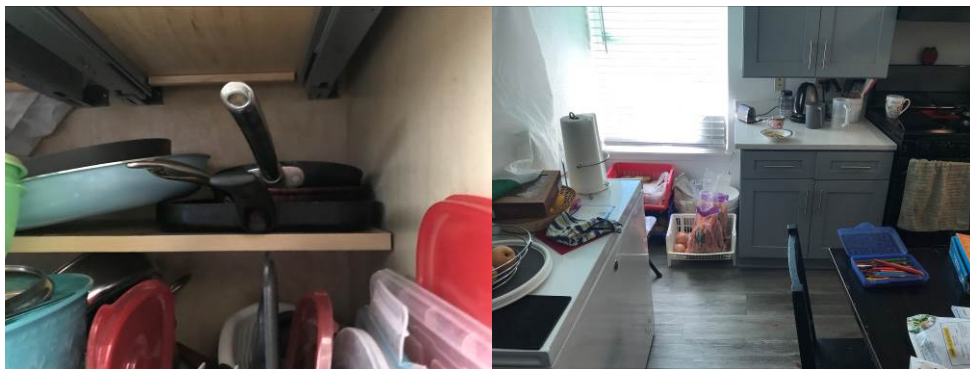
**Item #39 Deficiency:** Work Counter (2010 ADA 804.3, 804.6.5) Unit 4246B is designated as a mobility accessible dwelling unit and subject to ADA design requirements. The kitchen does not provide an accessible work counter with a minimum 30” wide accessible open knee space or removable cabinet beneath. Additional mobility accessible dwelling units were not inspected but may also be affected.

- **Corrective Action** – Provide an architect’s or accessibility specialist’s certification with photographic evidence that the condition has been corrected in the cited unit and all other mobility accessible dwelling units. The certification must verify that all accessible work counters meet the following conditions: 1) the counter height is no more than 34 inches above the floor; 2) an unobstructed 30 inch by 48 inch floor space is positioned to provide a forward (perpendicular) approach, with the 48 inch dimension measured from a point under the counter that is no more than 19 inches back from the front edge of the counter; 3) the work surface is positioned adjacent to one side of the bottom-hinged oven; 4) the minimum clearance beneath the counter is: (a) knee space is 8 inches deep (measured horizontally from the front edge of the counter) at a point that is 27 inches above the floor; (b) leg clearance is 11 inches deep at a point 9 inches high; and (c) toe clearance is at least 17 inches deep at a point at least 9 inches high; 5) any base cabinetry that conceals the knee, leg, and toe clearance below the counter is quickly and easily removable without removal or replacement of the counter or surrounding structure, the walls behind and surrounding the cabinetry are finished, and the finish floor extends under the cabinetry.
