ENFORCEMENT ACTION AGAINST	§	BEFORE THE
LIH WURZBACH MANOR, LP	§	TEXAS DEPARTMENT OF
WITH RESPECT TO	§	HOUSING AND COMMUNITY
WURZBACH MANOR APARTMENTS	§	AFFAIRS
(HTC FILE # 19413 / CMTS # 3277)	§

**AGREED FINAL ORDER**

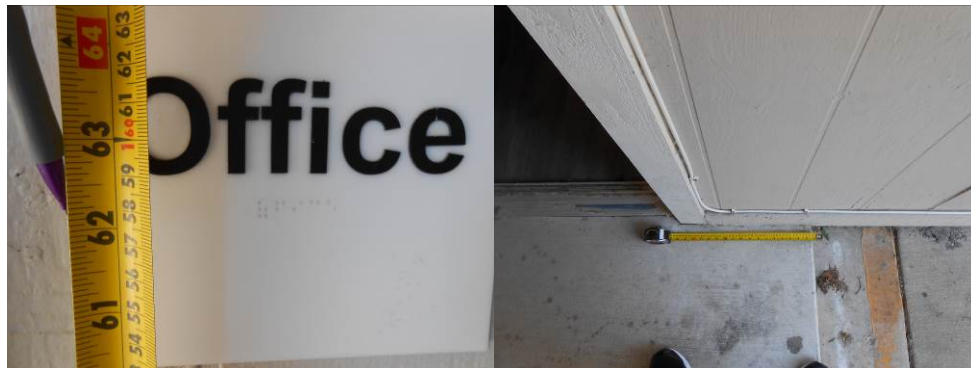
**Item #11 Deficiency:** Room and Egress Signage Height and Location (2010 ADA 216.2, 216.4.1, 703) This development is subject to ADA design requirements. The signs at doors identifying permanent rooms and spaces (leasing office) and dwelling units (4363C, 4311A) do not meet height requirements for accessible signage. Additionally, the signs at doors identifying dwelling units (4363B, 4311B) do not meet position requirements for accessible signage.

- **Corrective Action** – Please provide an architect’s or accessibility specialist’s certification with photographic evidence that the condition has been corrected at the location cited and throughout the property. The certification must verify that all room and space signage, including egress route signs, and excluding exterior room and space signs that are not located at a door, meets the technical specifications required under ADA 703, and specifically verifies the following conditions are provided: 1) a non-glare finish with text characters on a high-contrast background (light on dark or dark on light); 2) signs are located on either the push-side of the door face if it has a closer (not including spring hinges) and which do not have a hold-open device, or are located on the adjacent wall on the latch-side of the door; 3) a clear floor or ground surface beneath the sign that is at least 18 inches by 18 inches and is centered on the raised characters of the sign; 4) are positioned with

the baseline of the lowest row at or above 48 inches, and baseline of the highest row at or below 60 inches from the floor surface; and 5) any egress signs meet all local codes and ordinances.

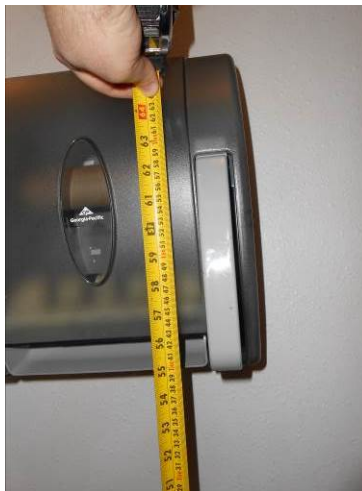
**Item #15 Deficiency:** Operable Parts (2010 ADA 205, 308-9) The leasing office is identified as a common use facility and employee work area subject to ADA design requirements. The paper towel dispenser in the unisex restroom is more than 48 inches above the floor and is not within accessible reach ranges.

- **Corrective Action** – Provide an architect’s or accessibility specialist’s certification with photographic evidence that the paper towel dispenser at this location and at all accessible spaces have been corrected or are already correct, do not require tight grasping, pinching, twisting of the wrist, are on an accessible route, and, where the clear floor space is positioned for an unobstructed side (parallel) approach, the height of the paper towel dispenser is 15-48 inches above the floor (an object that is less than or equal to 34 inches high and less than or equal to 10 inches deep is not considered an obstruction).

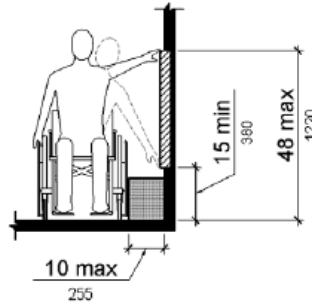
**Item #16 Deficiency:** Controls and Outlets (2010 ADA 205, 308-9) The leasing office is identified as a common use facility and employee work area subject to ADA design requirements. The thermostat (highest control) and light switch (“on” position) is more than 48 inches above the floor and is not within accessible reach ranges.

- **Corrective Action** – Provide an architect’s or accessibility specialist’s certification with photographic evidence that the control/switch at this location and all accessible spaces have been corrected or are already correct, are on an accessible route and, where the clear floor space is positioned for an unobstructed side (parallel) approach, the height of the control/switch is 15-48 inches above the floor (an object that is less than or equal to 34 inches high and less than or equal to 10 inches deep is not considered an obstruction).

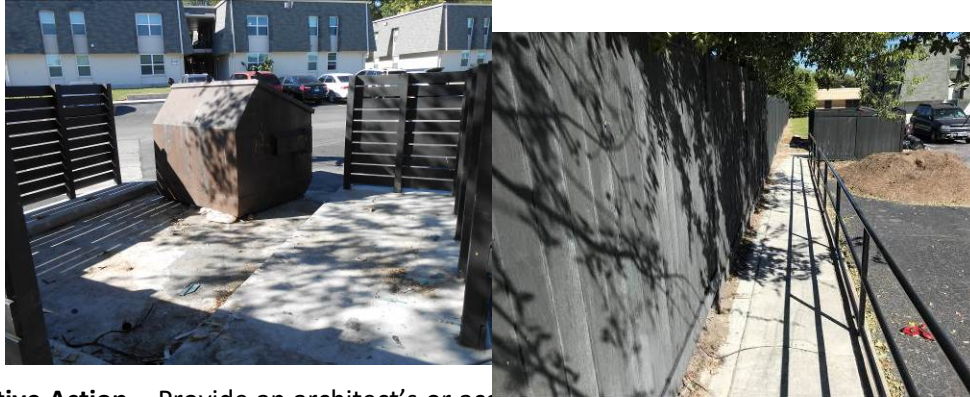
**Item #18 Deficiency: Trash Disposal (2010 ADA 205, 308-9)** The garbage dumpsters located throughout the property are identified as common use facilities and subject to ADA design requirements. The sill height of the opening of the dumpsters are more than 48 inches above the ground surface and not within accessible reach ranges and are not on an accessible route.

- **Corrective Action** – Provide an architect’s or accessibility specialist’s certification with photographic evidence that the garbage dumpster at this location and other accessible dumpsters have been corrected or are already correct. The certification must verify that trash facilities are provided with the use of accessible common-use dumpsters or with separate accessible receptacles for use by residents with disabilities. If separate receptacles are used, note that it may be necessary to designate them as reserved for disabled use only. The certification must also verify that all accessible trash facilities meet the following conditions: trash facilities are on an accessible route, and, where the clear floor space is positioned for an unobstructed side (parallel) approach, the height of the dumpster is 15-48 inches above the ground surface (an object that is less than or equal to 34 inches high and less than or equal to 10 inches deep is not considered an obstruction).

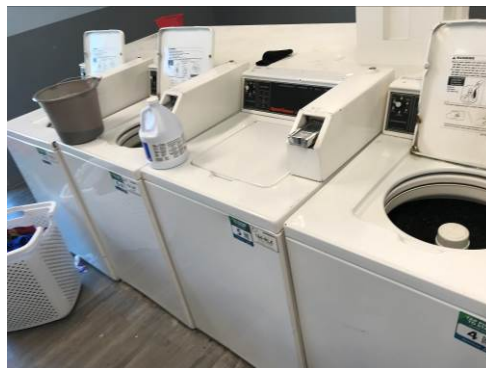
**Item #19 Deficiency:** Laundry Machines (TDHCA/2010 ADA 214, 611) The laundry room at the community center is identified as a common use facility serving accessible dwelling units and subject to TDHCA/ADA design requirements. The laundry room does not provide an accessible front-loading washing machine.

- **Corrective Action** – Provide an architect’s or accessibility specialist’s certification with photographic evidence that the laundry machines at this location have been corrected or are already correct. The certification must verify that applicable laundry rooms and accessible laundry machines are on an accessible route, and that at least one front-loading washer and dryer is provided in each accessible laundry room, and that the clear floor space at each accessible machine is positioned for a side (parallel) approach, and is centered on the machine with no obstruction within 24 inches on either side of the centerline, with unobstructed controls and operable parts at 15-48 inches above the floor.

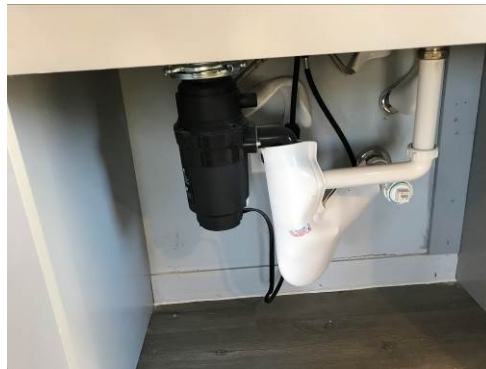
**Item #20 Deficiency:** Exposed Pipes (2010 ADA 606.5) The leasing office and community center are identified as common use facilities and subject to ADA design requirements. The kitchen sink does not provide adequate protection from exposed pipes and sharp or abrasive surfaces under the sink that may

cause injury to certain users. The drain line in the leasing office and community center kitchens are exposed where the flange meets the sink bowl. Additionally, the garbage disposal in the community center kitchen is exposed.

- **Corrective Action** – Please provide an architect's or accessibility specialist's certification with photographic evidence that the condition has been corrected at the location cited and throughout the accessible route for the property. The certification must verify the following: 1) water supply and drain pipes under sinks are insulated or otherwise configured to protect against contact; 2) there are no exposed sharp or abrasive surfaces under the sink; and 3) the minimum clearance beneath the sink is: (a) knee space is 8 inches deep (measured horizontally from the front edge of the sink counter) at a point that is 27 inches above the floor; (b) leg clearance is 11 inches deep at a point 9 inches high; and (c) toe clearance is at least 17 inches deep at a point at least 9 inches high.

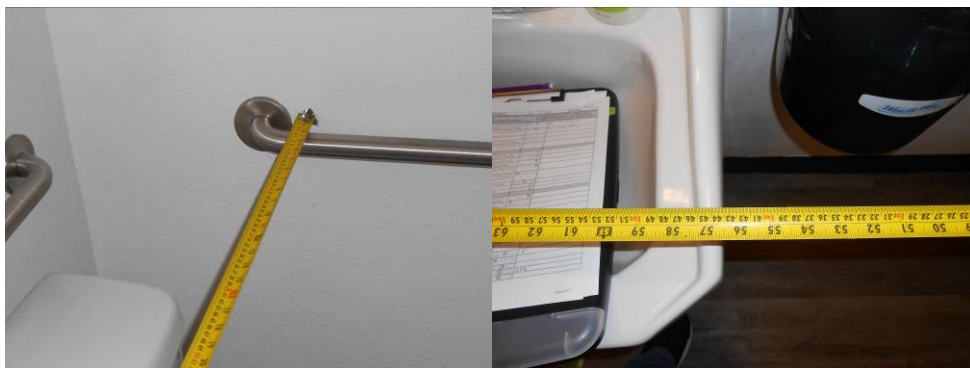
**Item #21 Deficiency: Toilet Clear Floor Space (2010 ADA 604.3)** The leasing office and community center are identified as common use facilities and subject to ADA design requirements. The accessible toilet in the unisex (leasing office), men's (community center), and women's (community center) restrooms do not provide an unobstructed clear floor space of the required dimensions. An overlapping lavatory cabinet is located within the required clear floor space.

- **Corrective Action:** Please provide an architect's or accessibility specialist's certification with photographic evidence that the condition has been corrected in all common use restrooms having these conditions. The certification must verify that the width of the clear floor space is at least 60 inches (side to side) and the depth is at least 56 inches (front to back). Note that only grab bars, dispensers, sanitary napkin disposal units, coat hooks, shelves, accessible routes, clear floor space required at other fixtures, and the turning space are permitted to overlap. Ensure that no other fixtures or obstructions are located within the required toilet clearance.

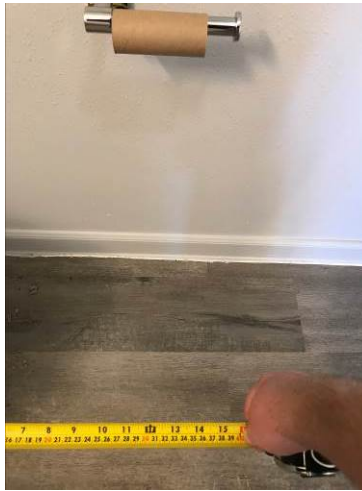
**Item #23 Deficiency: Toilet Paper Dispenser (2010 ADA 604.7)** The leasing office and community center are identified as common use facilities and subject to ADA design requirements. The toilet paper dispenser for the accessible toilet in the unisex (leasing office), men’s (community center), and women’s (community center) restrooms is not installed in an accessible location relative to the toilet. It was measured at more than 9 inches from the front of the toilet to the centerline of the dispenser.

- **Corrective Action** – Please provide an architect’s or accessibility specialist’s certification with photographic evidence that the condition has been corrected at the location cited and throughout the property. The certification must verify that the toilet paper dispenser at all accessible toilets meets the following conditions: 1) does not control delivery or prevent continuous paper flow; 2) centerline is located between 7 and 9 inches in front of the toilet bowl; 3) outlet is between 15 and 48 inches above the floor; and 4) is no less than 1½ inches to the bottom and no less than 12 inches to the top of the grab bar.

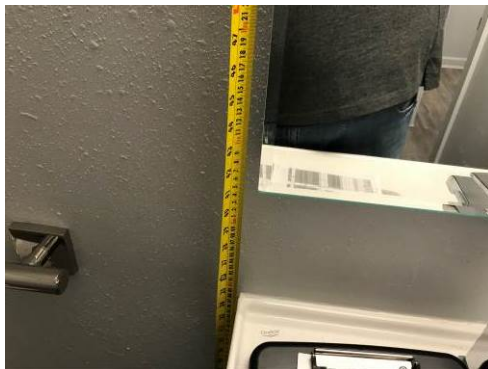
**Item #25 Deficiency: Mirror Height (2010 ADA 213.3.5)** The leasing office and community center are identified as common use facilities and subject to ADA design requirements. The mirror in the unisex (leasing office), men’s (community center), and women’s (community center) restrooms was more than 40 inches above the floor.

- **Corrective Action** – Please provide an architect’s or accessibility specialist’s certification with photographic evidence that the condition has been corrected at the location cited and throughout the accessible route for the property. The certification must verify that restroom mirrors are positioned with the bottom edge of the reflecting surface no higher than 40 inches above the floor.

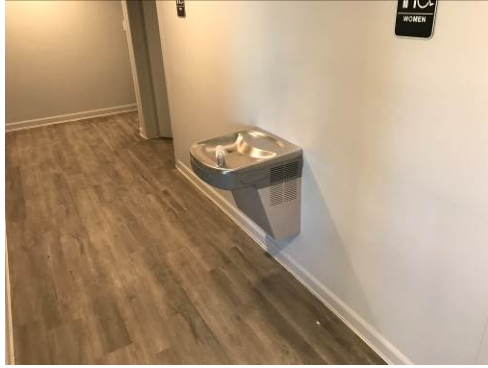
**Item #26 Deficiency: Drinking Fountain (2010 ADA 211, 602)** The community center is identified as a common use facility with a drinking fountain and subject to ADA design requirements. The drinking fountain did not provide both a high and a low spout at accessible heights.

- **Corrective Action** –Please provide an architect’s or accessibility specialist’s certification with photographic evidence that the condition has been corrected at the location cited and throughout the property. The certification must verify that for every drinking fountain location, both a high and a low fountain are provided, and at each location, at least 50% (fractions rounded up or down) are accessible and meet the following conditions: 1) high spouts are 38 to 43 inches high, and low spouts are no more than 36 inches above the floor; 2) spout location is no closer than 15 inches from the vertical support behind the spout, and no further than 5 inches from the front of the unit; 3) water flow at fountains is at least 4 inches high, and flows parallel with the front of the fountain; and 4) open knee, leg and toe clearance is provided beneath and fountains are positioned for a forward approach.

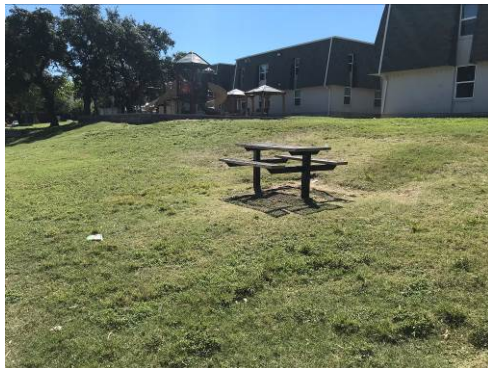
**Item #27 Deficiency:** Tables & Work Surfaces (2010 ADA 226, 902) The common use picnic table located near the playground is subject to ADA design requirements. The picnic table is not connected with the accessible route for the property.

- **Corrective Action** – Please provide an architect’s or accessibility specialist’s certification with photographic evidence that the condition has been corrected at the location cited and throughout the property. The certification must verify that at least 5% of all common use picnic tables on the property meets the technical specifications required under the 2010 ADA, and specifically verifies that the following design features are provided for each accessible picnic table: 1) a minimum 30 inch by 48 inch clear floor or ground space provides one unobstructed side located adjacent to the accessible route for the property, and is positioned for a forward (front) approach; 2) top surface is 28 to 34 inches high; and 3) open space beneath accessible tables and work surfaces provides the required knee, leg and toe clearances.

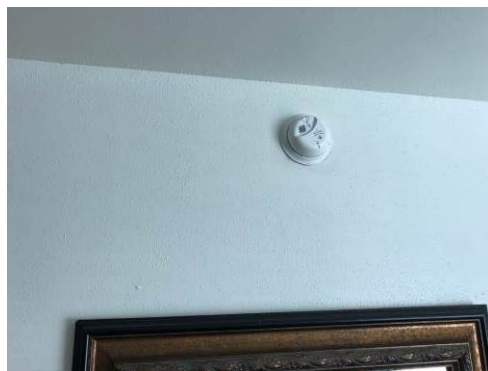
**Item #31 Deficiency:** Strobe Alarm (2010 ADA 809.5.2-3) Unit 4351C is designated as a unit required to provide accessible communication features and subject to ADA design requirements. The designated sight and hearing accessible unit did not provide operating strobe-type smoke detectors (living room). Additional dwelling units required to provide accessible communication features were not inspected but may also be affected.

- **Corrective Action** – Please provide an architect’s or accessibility specialist’s certification with photographic evidence that the condition has been corrected in the cited unit and all other units required to provide accessible communication features. The certification must verify that sight and hearing accessible units meet the following conditions: 1) all appliances activate upon smoke detection and are visible and audible detector/alarms in compliance with NFPA 72 (1999 or 2002 edition); and 2) appliances are provided in all sleeping rooms, in common hallways serving sleeping rooms, and on each level of multilevel units in compliance with Chapter 92 of the Texas Property Code.

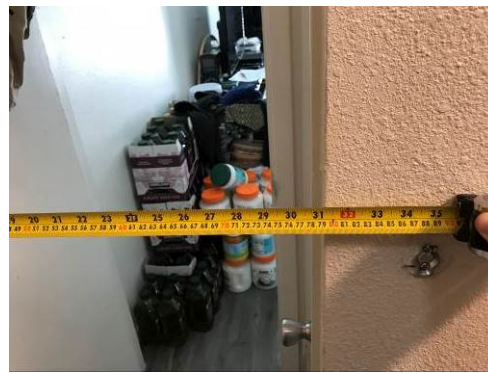
**Item #32 Deficiency: Accessible Route Width (2010 ADA 603.2.3)** Units 4311B and 4246B are designated as mobility accessible dwelling units and subject to ADA design requirements. The route between the master bedroom and the master bathroom is required to be an accessible route, however, it does not meet the minimum width requirement for an accessible route. Additional mobility accessible dwelling units were not inspected but may also be affected.

- **Corrective Action** – Please provide an architect’s or accessibility specialist’s certification with photographic evidence that the condition has been corrected in the cited unit and all other mobility accessible dwelling units. The certification must verify that the entire route provides a minimum width of 36 inches. Note that route width is permitted to be reduced to 32 inches for short segments of the route no greater than 24 inches long, and where multiple reduced-width segments are separated by segments that are at least 48 inches long and at least 36 inches wide (see illustration).

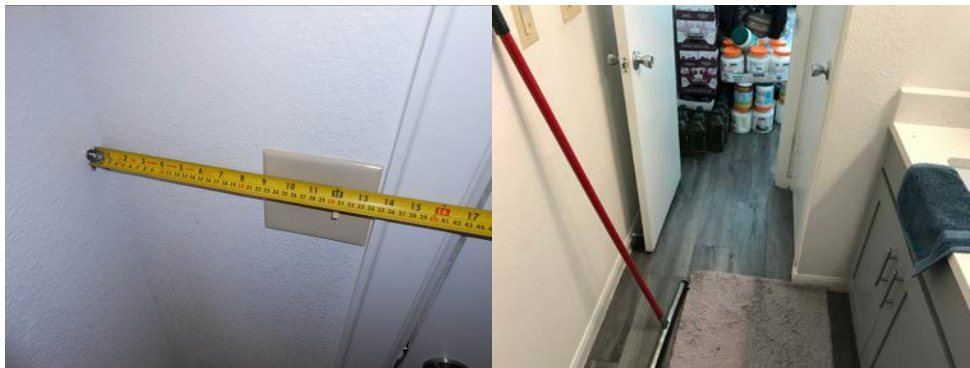
**Item #36 Deficiency:** Door Maneuvering Clearance (2010 ADA 404.2.4, 809.2) Units 4334B, 4311B, and 4246B are designated as mobility accessible dwelling units and subject to ADA design requirements. All passage doors on accessible routes are required to comply with door maneuvering clearance requirements, including the non-complying bathroom. The master bathroom (units 4311B and 4246B) and bedroom doors (unit 4334B) do not provide an unobstructed landing or floor space for maneuvering on the interior side that is of the required dimensions for the approach conditions for a passage door on an accessible route. Specifically, there is not 18 inches beyond the latch on the pull side of the doors. Additional mobility accessible dwelling units were not inspected but may also be affected.

- **Corrective Action** – Provide an owner’s certification with photographic evidence (one sample photo only) that the condition has been corrected in the cited units and all other mobility accessible dwelling units. Ensure that the door at this location and at all other interior and exterior passage doors on accessible routes provide a landing or floor surface area on both sides of the door that is unobstructed and level (max. 2% slope) within the perimeter dimensions illustrated below. This includes a clear floor area that extends 18 inches beyond the latch side of a door that must be pulled to open (see upper left diagram).

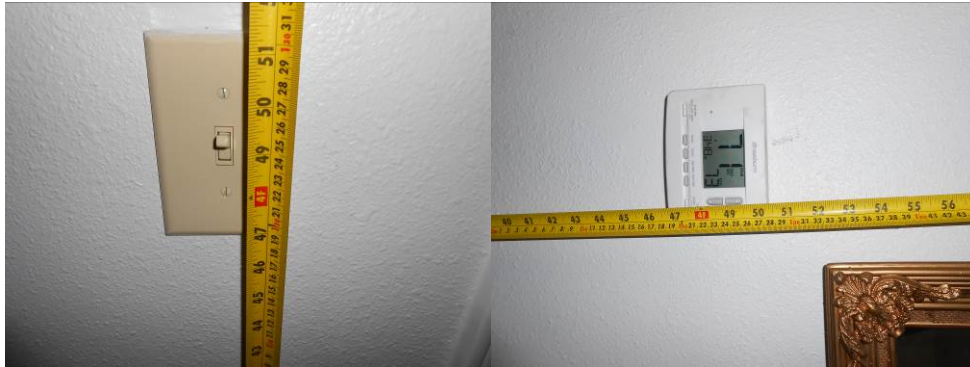
**Item #38 Deficiency:** Controls and Outlets (2010 ADA 205, 308-9) Units 4363B and 4246B are identified as mobility accessible dwelling units and subject to ADA design requirements. The thermostat controls (units 4363B and 4246B) and light switch near the front door (4363B) are more than 48 inches above the floor and not within accessible reach ranges. Additional mobility accessible dwelling units were not inspected but may also be affected.

- **Corrective Action** – Provide an architect’s or accessibility specialist’s certification with photographic evidence that the thermostat and light switch at the cited unit and all other mobility accessible dwelling units have been corrected or are already correct. The certification must verify that all accessible thermostats and light switches are on an accessible route, and, where the clear floor space is positioned for an unobstructed side (parallel) approach, the height of the control/switch is 15-48 inches above the floor (an object that is less than or equal to 34 inches high and less than or equal to 10 inches deep is not considered an obstruction).

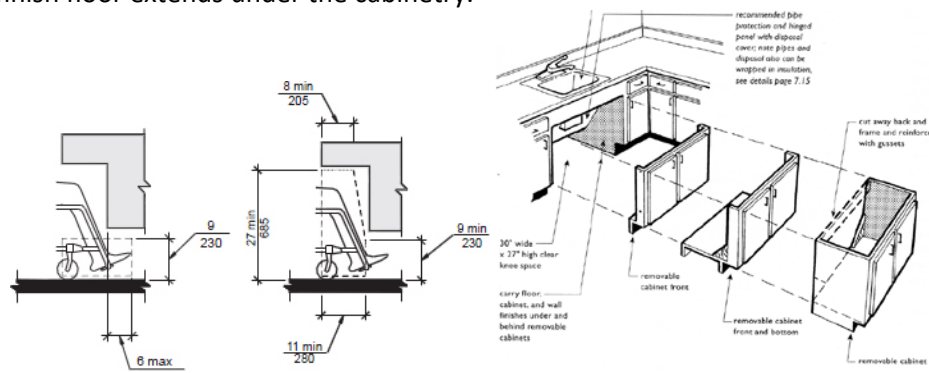
**Item #39 Deficiency:** Work Counter (2010 ADA 804.3, 804.6.5) Unit 4246B is designated as a mobility accessible dwelling unit and subject to ADA design requirements. The kitchen does not provide an accessible work counter with a minimum 30” wide accessible open knee space or removable cabinet beneath. Additional mobility accessible dwelling units were not inspected but may also be affected.

- **Corrective Action** – Provide an architect’s or accessibility specialist’s certification with photographic evidence that the condition has been corrected in the cited unit and all other mobility accessible dwelling units. The certification must verify that all accessible work counters meet the following conditions: 1) the counter height is no more than 34 inches above the floor; 2) an unobstructed 30 inch by 48 inch floor space is positioned to provide a forward (perpendicular) approach, with the 48 inch dimension measured from a point under the counter that is no more than 19 inches back from the front edge of the counter; 3) the work surface is positioned adjacent to one side of the bottom-hinged oven; 4) the minimum clearance beneath the counter is: (a) knee space is 8 inches deep (measured horizontally from the front edge of the counter) at a point that is 27 inches above the floor; (b) leg clearance is 11 inches deep at a point 9 inches high; and (c) toe clearance is at least 17 inches deep at a point at least 9 inches high; 5) any base cabinetry that conceals the knee, leg, and toe clearance below the counter is quickly and easily removable without removal or replacement of the counter or surrounding structure, the walls behind and surrounding the cabinetry are finished, and the finish floor extends under the cabinetry.

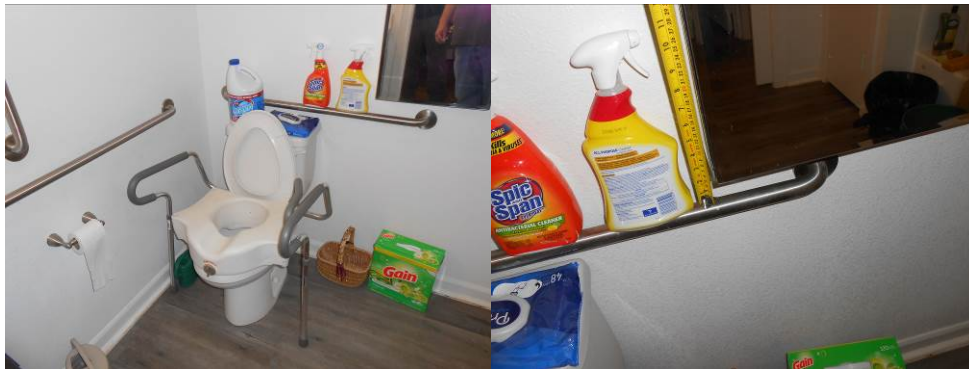
**Item #40 Deficiency: Grab Bar Height & Clearance (2010 ADA 609, 609.4)** Unit 4334B is designated as a mobility accessible dwelling unit and subject to ADA design requirements. The grab bar at the toilet in the accessible bathroom does not provide the required minimum clearance. Specifically, the space between the rear grab bar and the medicine cabinet above is not 12 inches minimum. Additional mobility accessible dwelling units were not inspected but may also be affected.

- **Corrective Action** – Please provide an architect’s or accessibility specialist’s certification with photographic evidence that the condition has been corrected in the cited unit and all other mobility accessible dwelling units. The certification must verify that grab bars meet each of the following conditions: 1) grab bars are securely-mounted and do not rotate in their fittings; 2) are 1¼ inches to 1½ inches in diameter; 3) grab bars located in the positions that are specified for grab bars at toilets, showers and bathtubs are mounted with the center of the bars at 33 inches to 36 inches above the floor (except the lower grab bar at the back wall of bathtubs); 4) all grab bars located in the

positions that are specified for grab bars at toilets, showers and bathtubs are mounted horizontally; and 5) all specified and non-specified grab bars provide at least 1½” of clearance between the grab bar and any obstruction and 12 inches minimum from the grab bars and any protruding object above it (e.g., soap dish, spray unit bar, valve, and other bars).

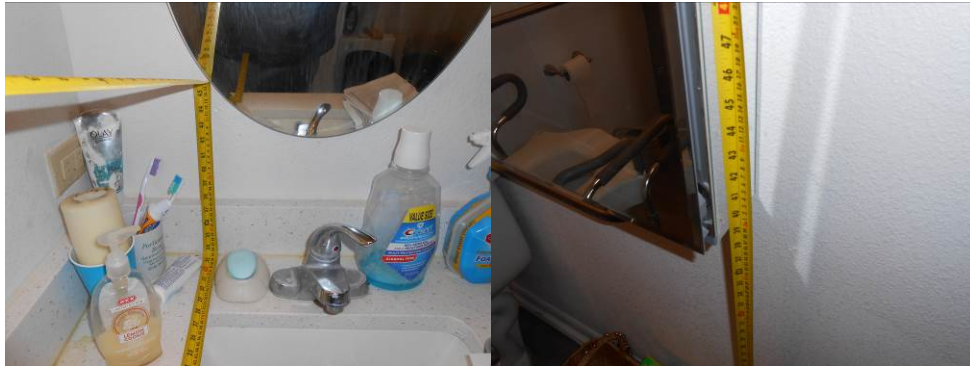
**Item #41 Deficiency: Mirror Height (2010 ADA 603.3)** Units 4363B, 4334B, 4311B, and 4246B are designated as mobility accessible dwelling units and subject to ADA design requirements. The mirror above the lavatory in the accessible bathroom was measured at more than 40 inches above the floor. Additionally, the medicine cabinet mirror not above the lavatory in the accessible bathroom was measured at more than 35 inches above the floor. Additional mobility accessible dwelling units were not inspected but may also be affected.

- **Corrective Action** – Please provide an architect’s or accessibility specialist’s certification with photographic evidence that the condition has been corrected in the cited unit and all other mobility accessible dwelling units. The certification must verify that bathroom mirrors at accessible lavatories are positioned with the bottom edge of the reflecting surface no higher than 40 inches above the floor or mirrors not located above lavatories are positioned with the bottom edge of the reflecting surface 35 inches maximum above the floor. Where mirrors are provided, at least one shall comply with 603.3.

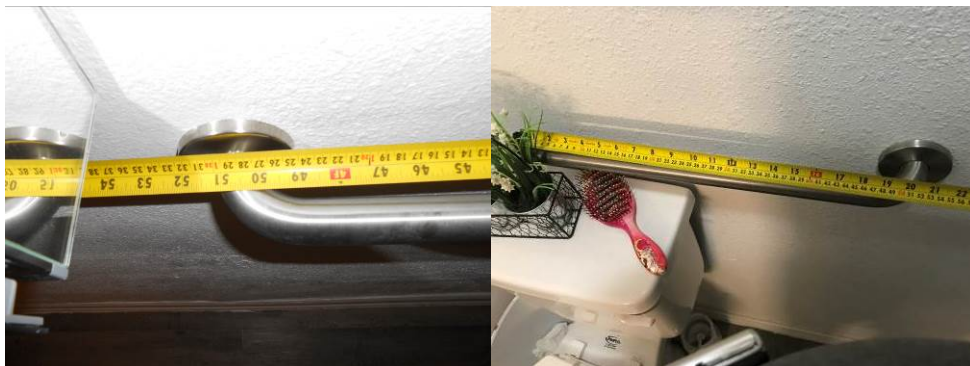
**Item #42 Deficiency: Toilet Grab Bars (2010 ADA 604.5)** Units 4363B, 4311B, and 4246B are designated as mobility accessible dwelling units and subject to ADA design requirements. The grab bars located at the side and back of the toilet in the accessible bathroom were not mounted in an accessible location. The side grab bar in units 4363B and 4311B is 42 inches long and extends less than 54 inches from the corner. The rear grab bar in unit 4311B is 36 inches long and the end nearest to the sidewall extends less than 12 inches from the centerline of the toilet. The rear grab bar in unit 4246B is 36 inches long and the end on the transfer side extends less than 24 inches from the centerline of the toilet. Additional mobility accessible dwelling units were not inspected but may also be affected.

- **Corrective Action** – Please provide an architect’s or accessibility specialist’s certification with photographic evidence that the condition has been corrected in the cited unit and all other mobility accessible dwelling units. The certification must verify that all of the following installation requirements have been met for toilet grab bars that are currently installed, or, if not installed, that reinforcement has been installed in walls and located so as to permit the installation of grab bars that meet all of the following features: 1) grab bars are mounted horizontally, securely and will not rotate in their fittings; 2) bars are 1¼ inches to 1½ inches in diameter; 3) the center of the bars is 33 inches to 36 inches above the floor; 4) bars have at least 1½ inches clearance and are not obstructed by any dispenser, any other inaccessible grab bar, fixture or architectural element; 5) the sidewall bar is at least 42 inches long with one end positioned no more than 12 inches, and with the other end no less than 54 inches from the corner; 6) bar at the back is at least 36 inches long and positioned so that the end nearest to the sidewall is no less than 12 inches from the centerline of the toilet, and the other end is no less than 24 inches from the toilet centerline.

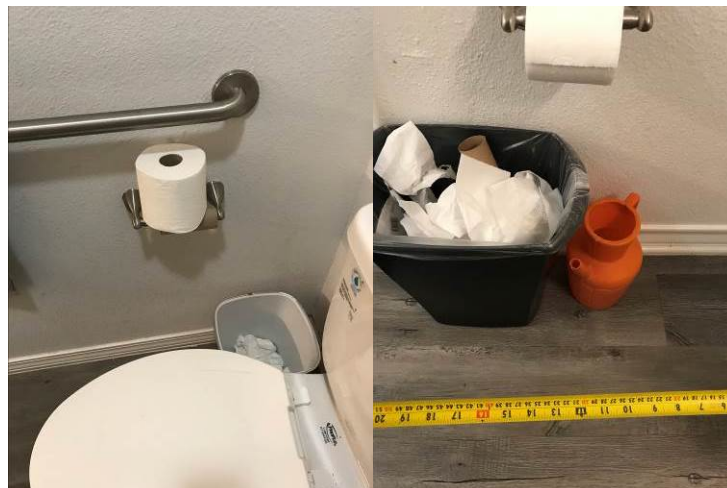
**Item #43 Deficiency: Toilet Paper Dispensers (2010 ADA 604.7)** Units 4363B, 4311B, and 4246B are designated as mobility accessible dwelling units and subject to ADA design requirements. The toilet paper dispenser in the accessible bathroom is not installed in an accessible location relative to the toilet. The centerline of the dispenser was not located between 7 and 9 inches from the front of the toilet. Additional mobility accessible dwelling units were not inspected but may also be affected.

- **Corrective Action** – Please provide an architect’s or accessibility specialist’s certification with photographic evidence that the condition has been corrected in the cited unit and all other mobility accessible dwelling units. The certification must verify that the toilet paper dispenser in all accessible bathrooms meets the following conditions: 1) does not control delivery or prevent

continuous paper flow; 2) centerline is located between 7 and 9 inches in front of the toilet bowl; 3) outlet is between 15 and 48 inches above the floor; and 4) is no less than 1½ inches to the bottom and no less than 12 inches to the top of the grab bar.
